TBF/TBM Avenger

Walk Around Number 25
squadron/signal publications

By Lou Drendel

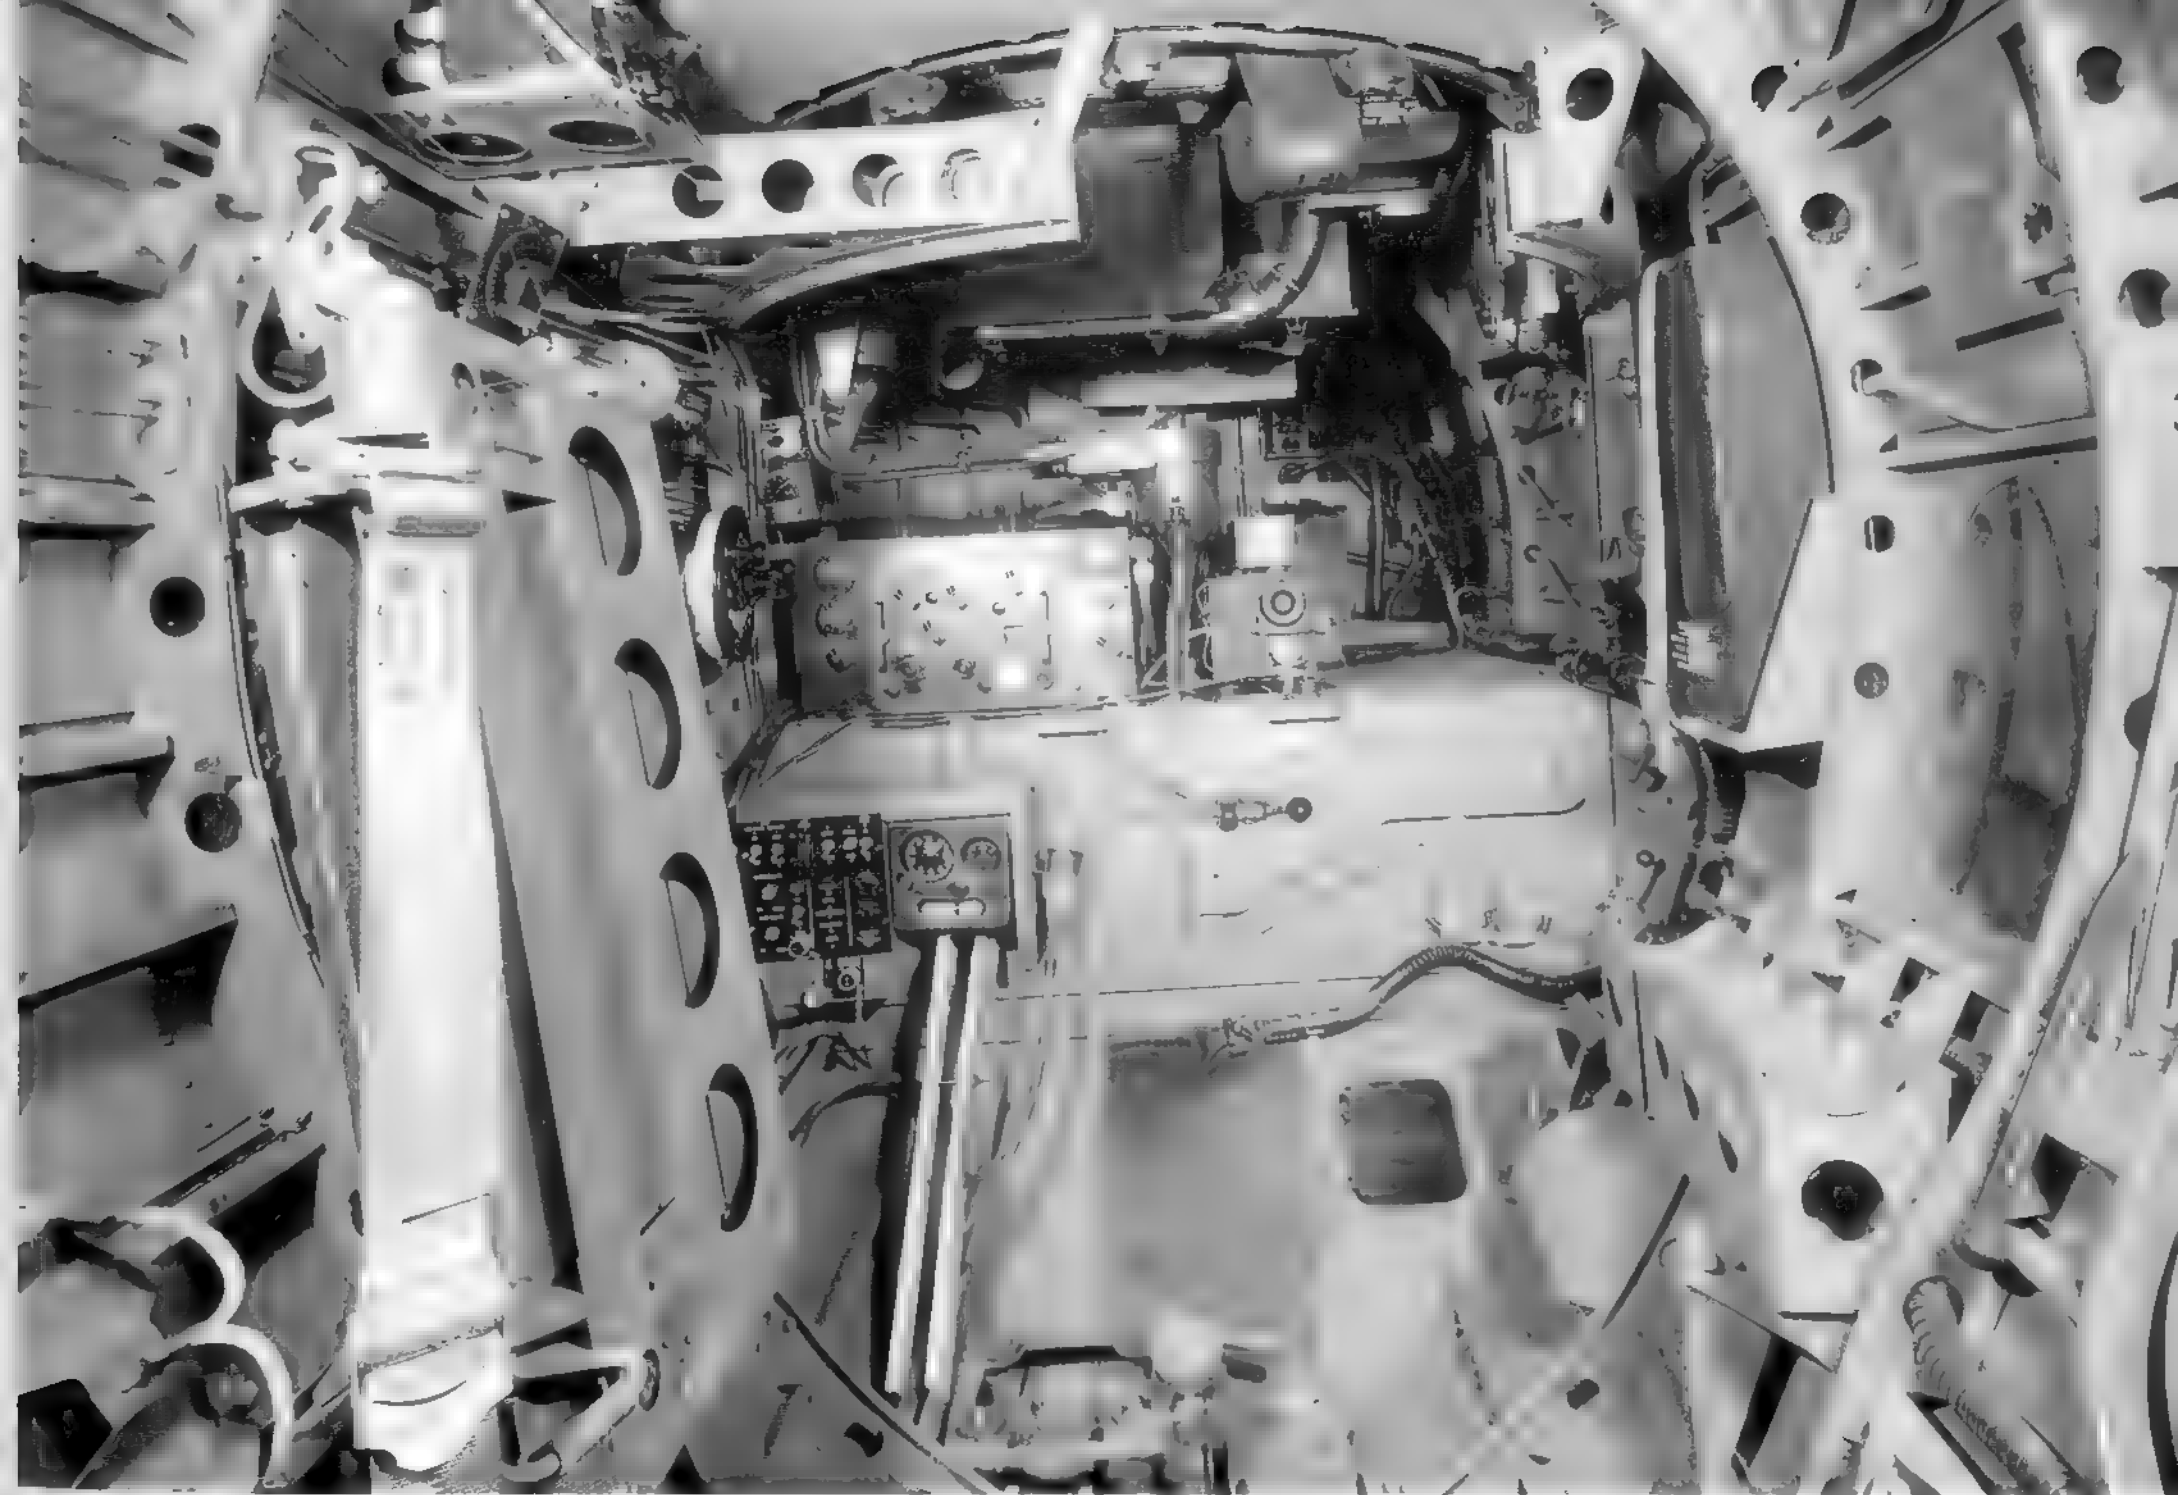
The TBF/TBM bombardier's station was located within the lower aft fuselage. The lower window – covered on the opposite side – looked into the bomb bay. The bombardier aimed through this window when the Avenger was on a level bombing mission. A radio trans-

mitter was placed above the bomb bay window. The bombardier's centerline seat was folded to port; this replaced a port mounted seat fitted to early TBF-1s. The turret and the radio operator's position were accessed from this compartment. (Lou Drendel)

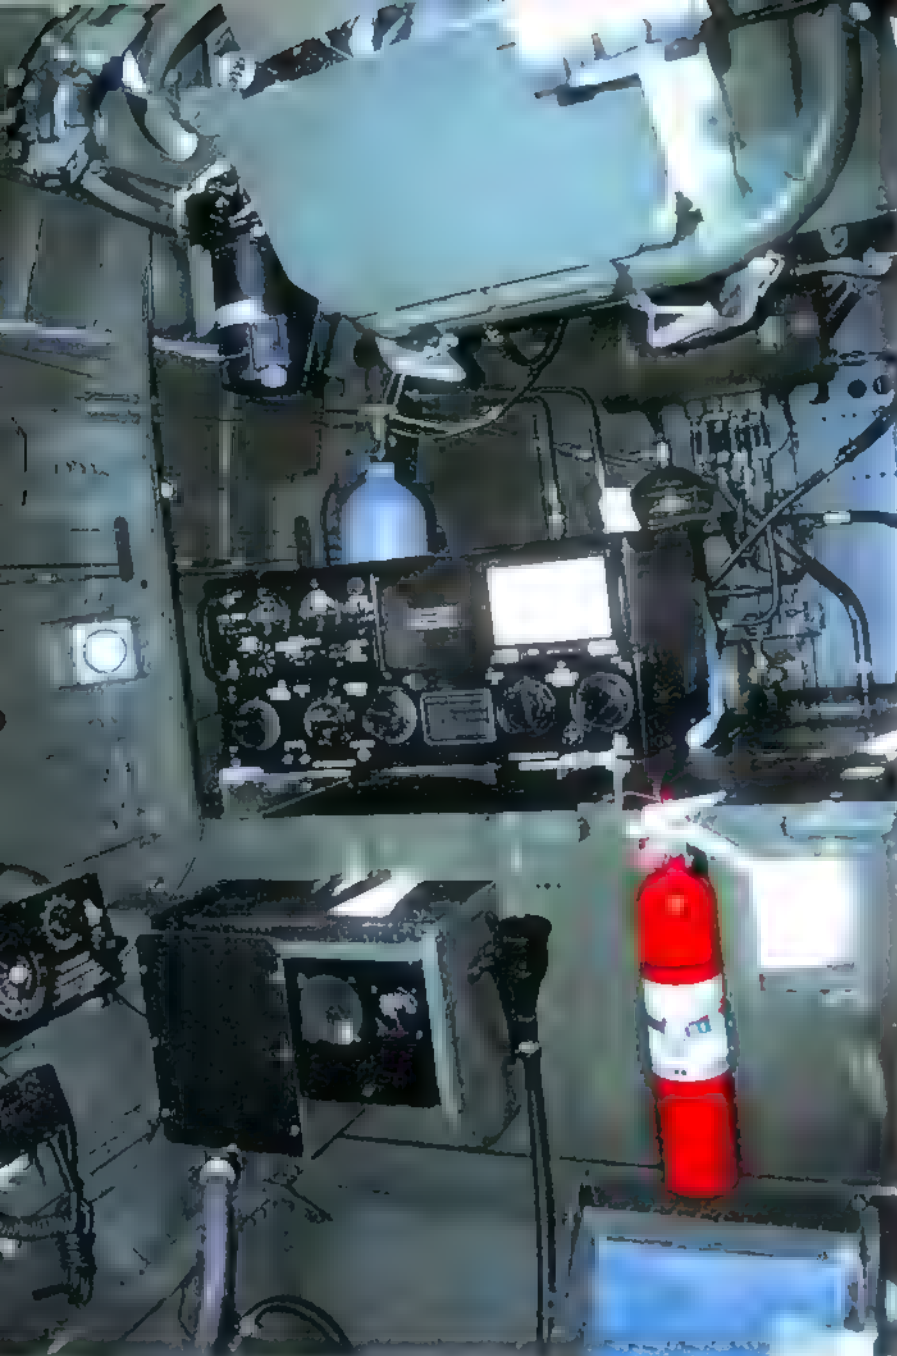
The interior of the Cavanaugh Flight Museum's TBM-3 is nearly flawless in its authentic appearance; however, the period radio equipment in the navigator/bombardier compartment is not operational. The small black box with the crank along the port wall is the intervalometer, which controlled the spacing of bombs released from the bomb bay. The bombardier set this device prior to dropping the ordnance onto the target. The overall interior finish on Eastern-built Avengers was Interior Green (FS34151). (Lou Drendel)

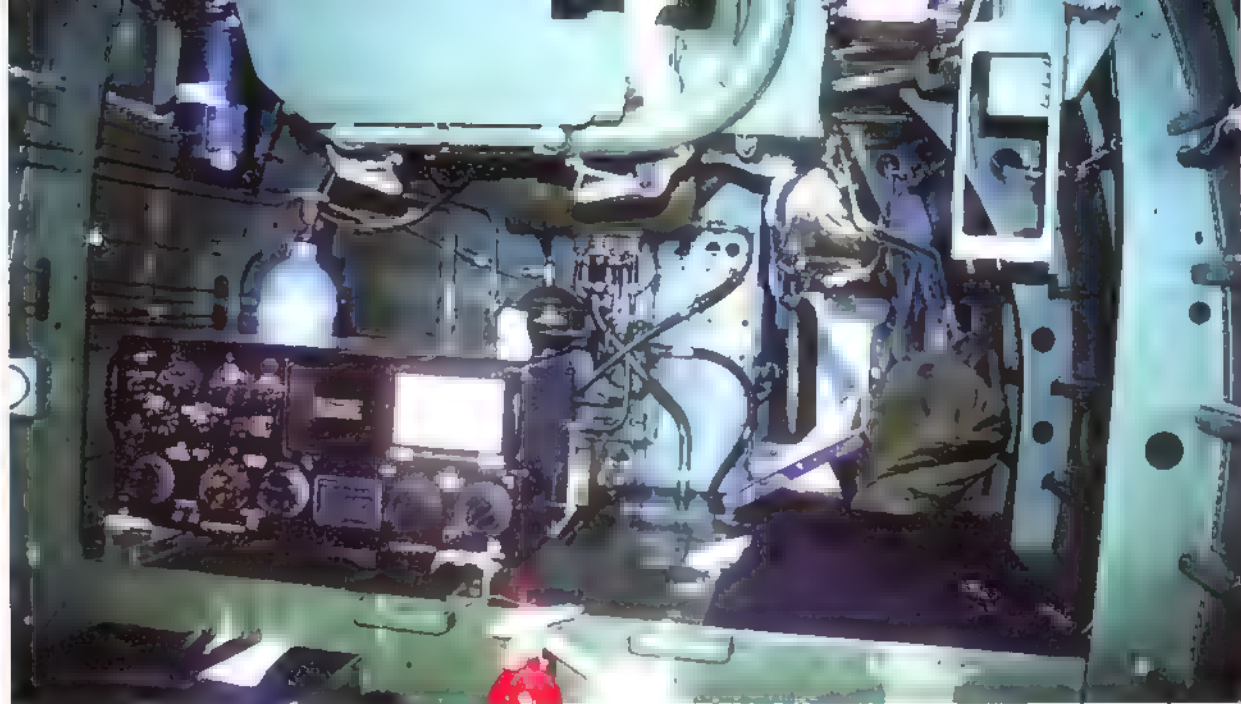
A red fire extinguisher – required modern flight safety equipment – was placed beside the bomb aiming window by the museum's staff. The turret gunner's lower armor plate hung from the turret position in the bombardier compartment's roof. This plate folded up when additional compartment space was needed. The starboard passageway led past the turret to the radio operator's cockpit in the fuselage's midsection. (Lou Drendel)

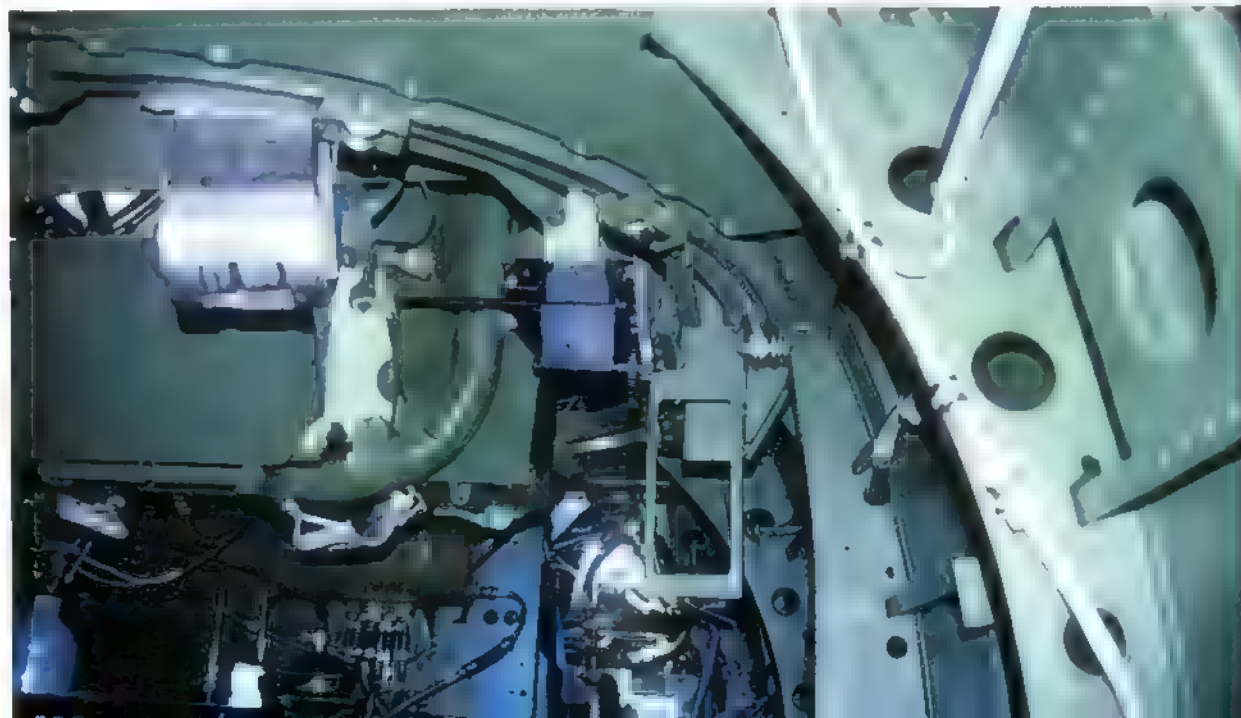
Brown seat belt attachments were fitted to the lower turret assembly. The canvas lap belt secured the gunner to his seat in flight. The step in the center right ceiling assisted the radio operator to climb into his mid fuselage seat. Behind this step is the turret interrupter gear, which was mounted on the turret azimuth ring. This device rotated with the turret and prevented the gunner from accidentally firing on his own aircraft. The interrupter gear replaced a cutout gear fitted to early Avengers. (Lou Drendel)

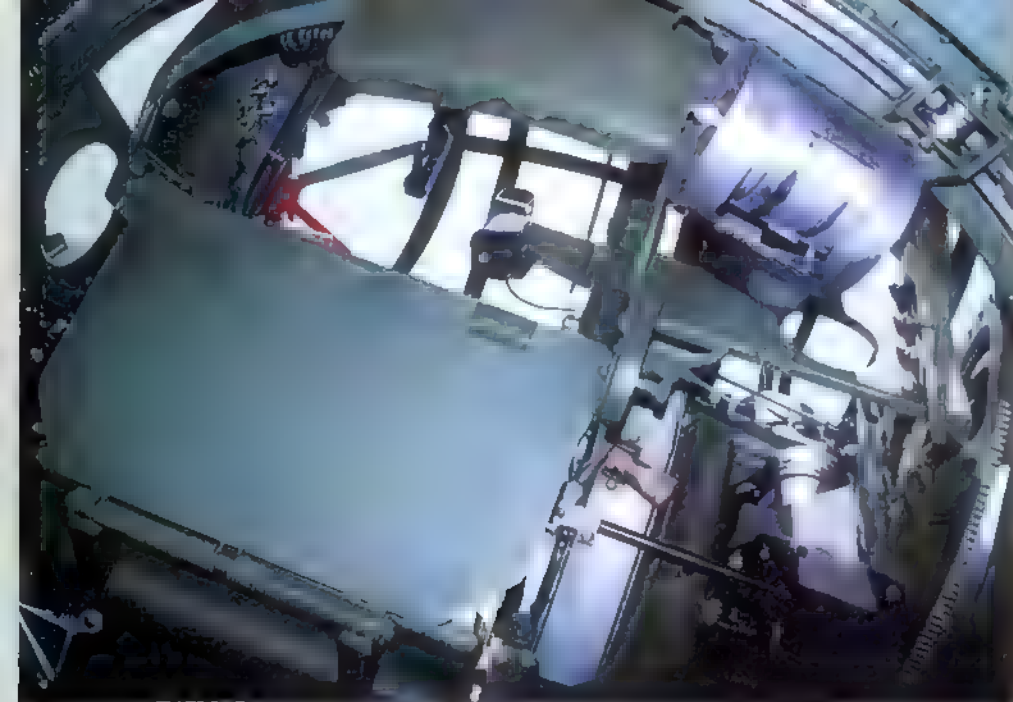
The .75 inch (19.1mm) thick lower armor plate served as a footrest for the turret gunner. His seat was also armor plated for protection from bullets and cannon shells. The silver cylinder beside the turret ring was one of the two electric motors used to revolve and elevate the turret. The turret's electric motors employed the Amplidyne form of control, which governed both the torque and speed of a motor with great precision. (Lou Drendel)

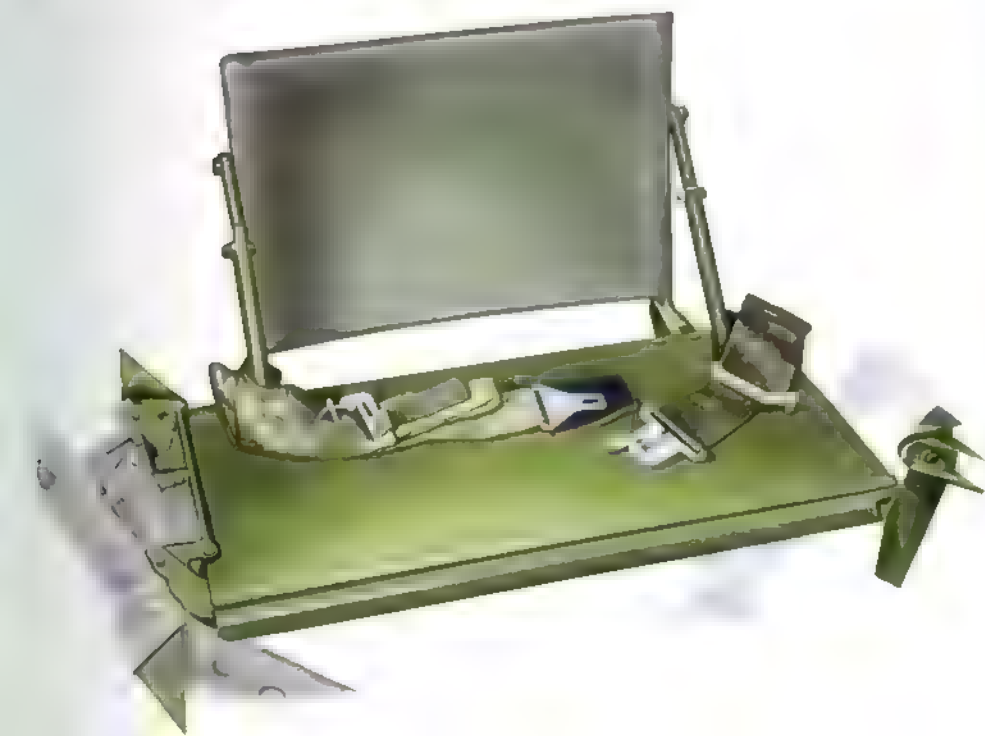
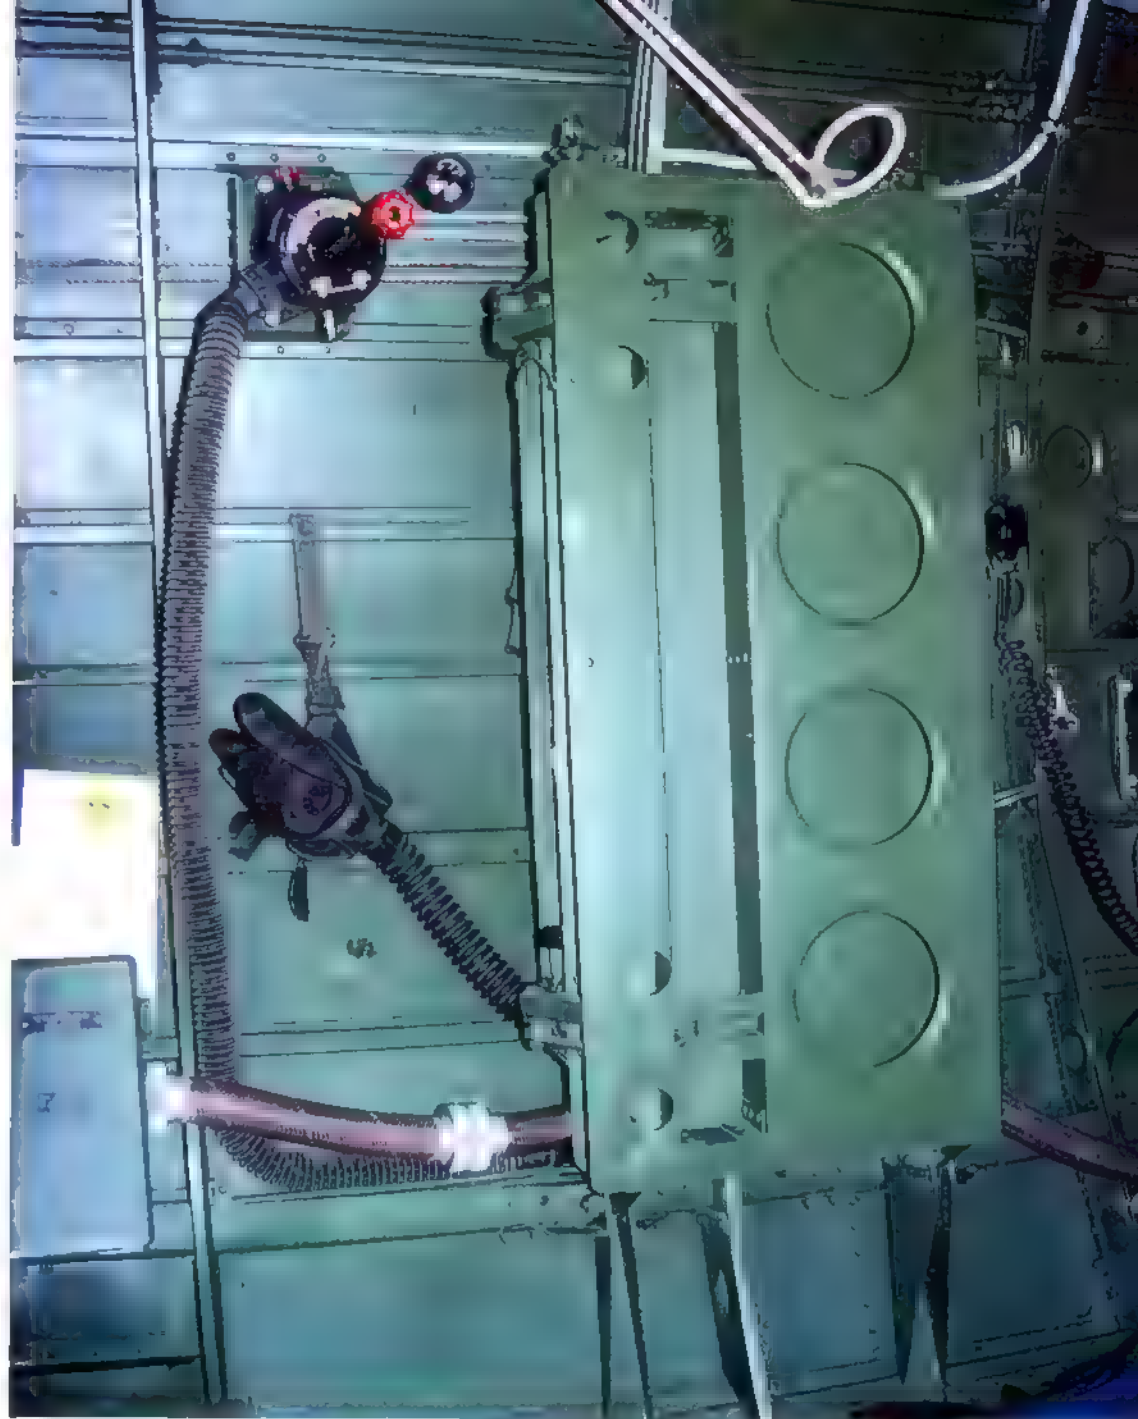
Bombardier's Seat

The radio operator/navigator/bombardier seat retracted to rest against the port side of the cabin wall beneath the turret. The seat back was folded forward prior to the seat being stowed. Behind the seat along the cabin wall is the radio operator's oxygen mask. This mask was connected to a hose, which was fitted to the oxygen regulator. He and the other two crewmen drew oxygen for high altitude flights from a 514 cubic inch (8422.9 cm³) cylinder mounted in the rear cockpit. (Lou Drendel)

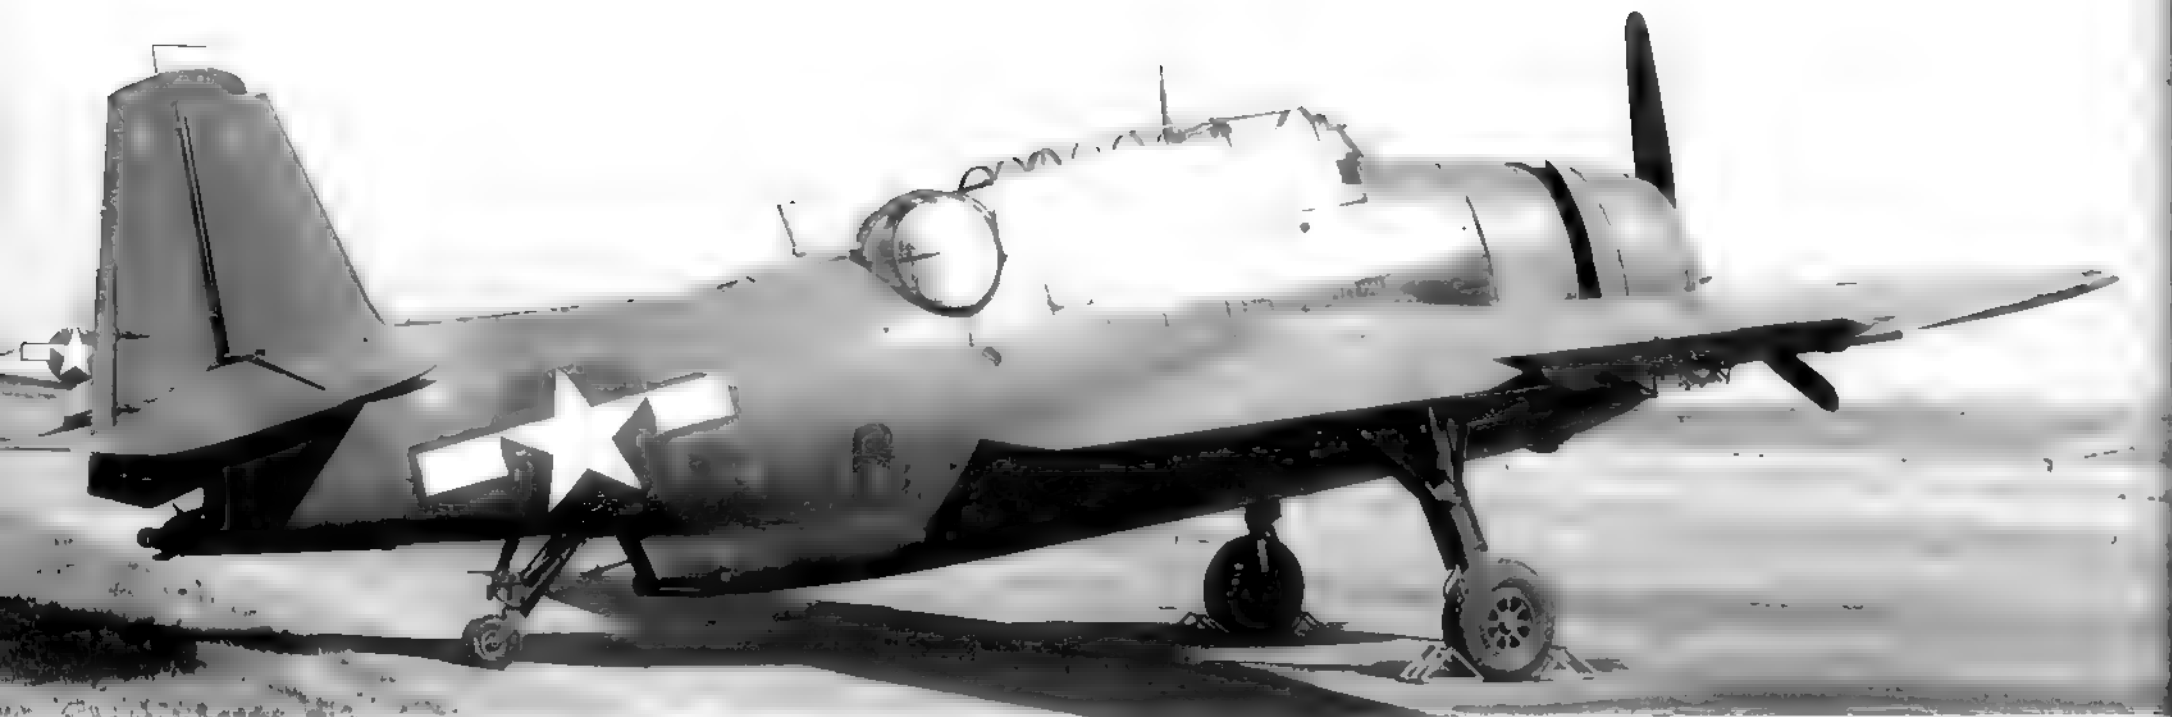
(Below) This restored TBM-3 was equipped with a replica .30 caliber machine gun in the ventral position. The TBM-3M model usually deleted the 'stinger' and the windows found in earlier models; this aircraft lacked the ventral side windows. The .30 caliber Colt-Browning M2 machine gun had a cyclic rate of 1200 rounds per minute and a muzzle velocity of 2800 feet (853.4 m) per second. (Glen Phillips)

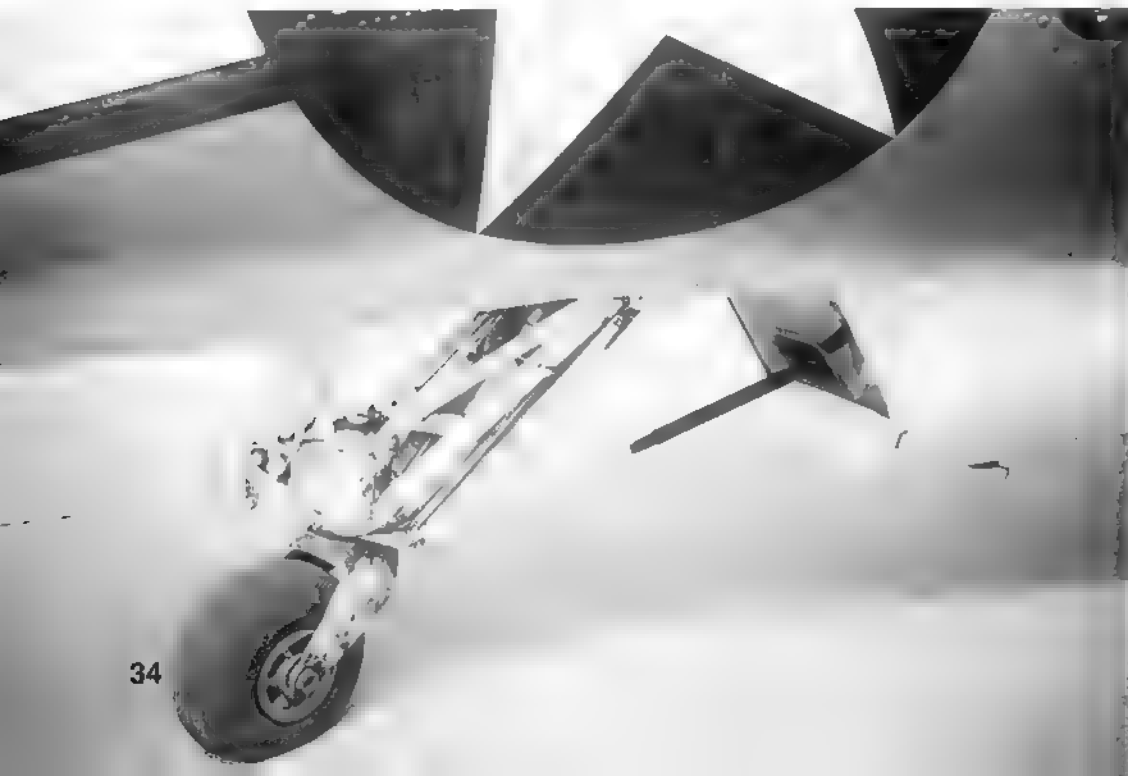
(Above) This TBM-3E was assigned to the Naval Air Reserve at Cleveland, Ohio in March of 1946. The ventral 'stinger' was fitted with a .30 caliber (7.62mm) Colt-Browning M2 machine gun. The post placed on the barrel was part of the weapon's ring and post gun-sight. The radio operator manned this gun to defend the Avenger against enemy fighters from the rear and below. He fired the weapon from a hunched position in the aft fuselage gun tunnel. The sun's glare has caused the canopy to appear 'washed out.' (Warren Bodie)

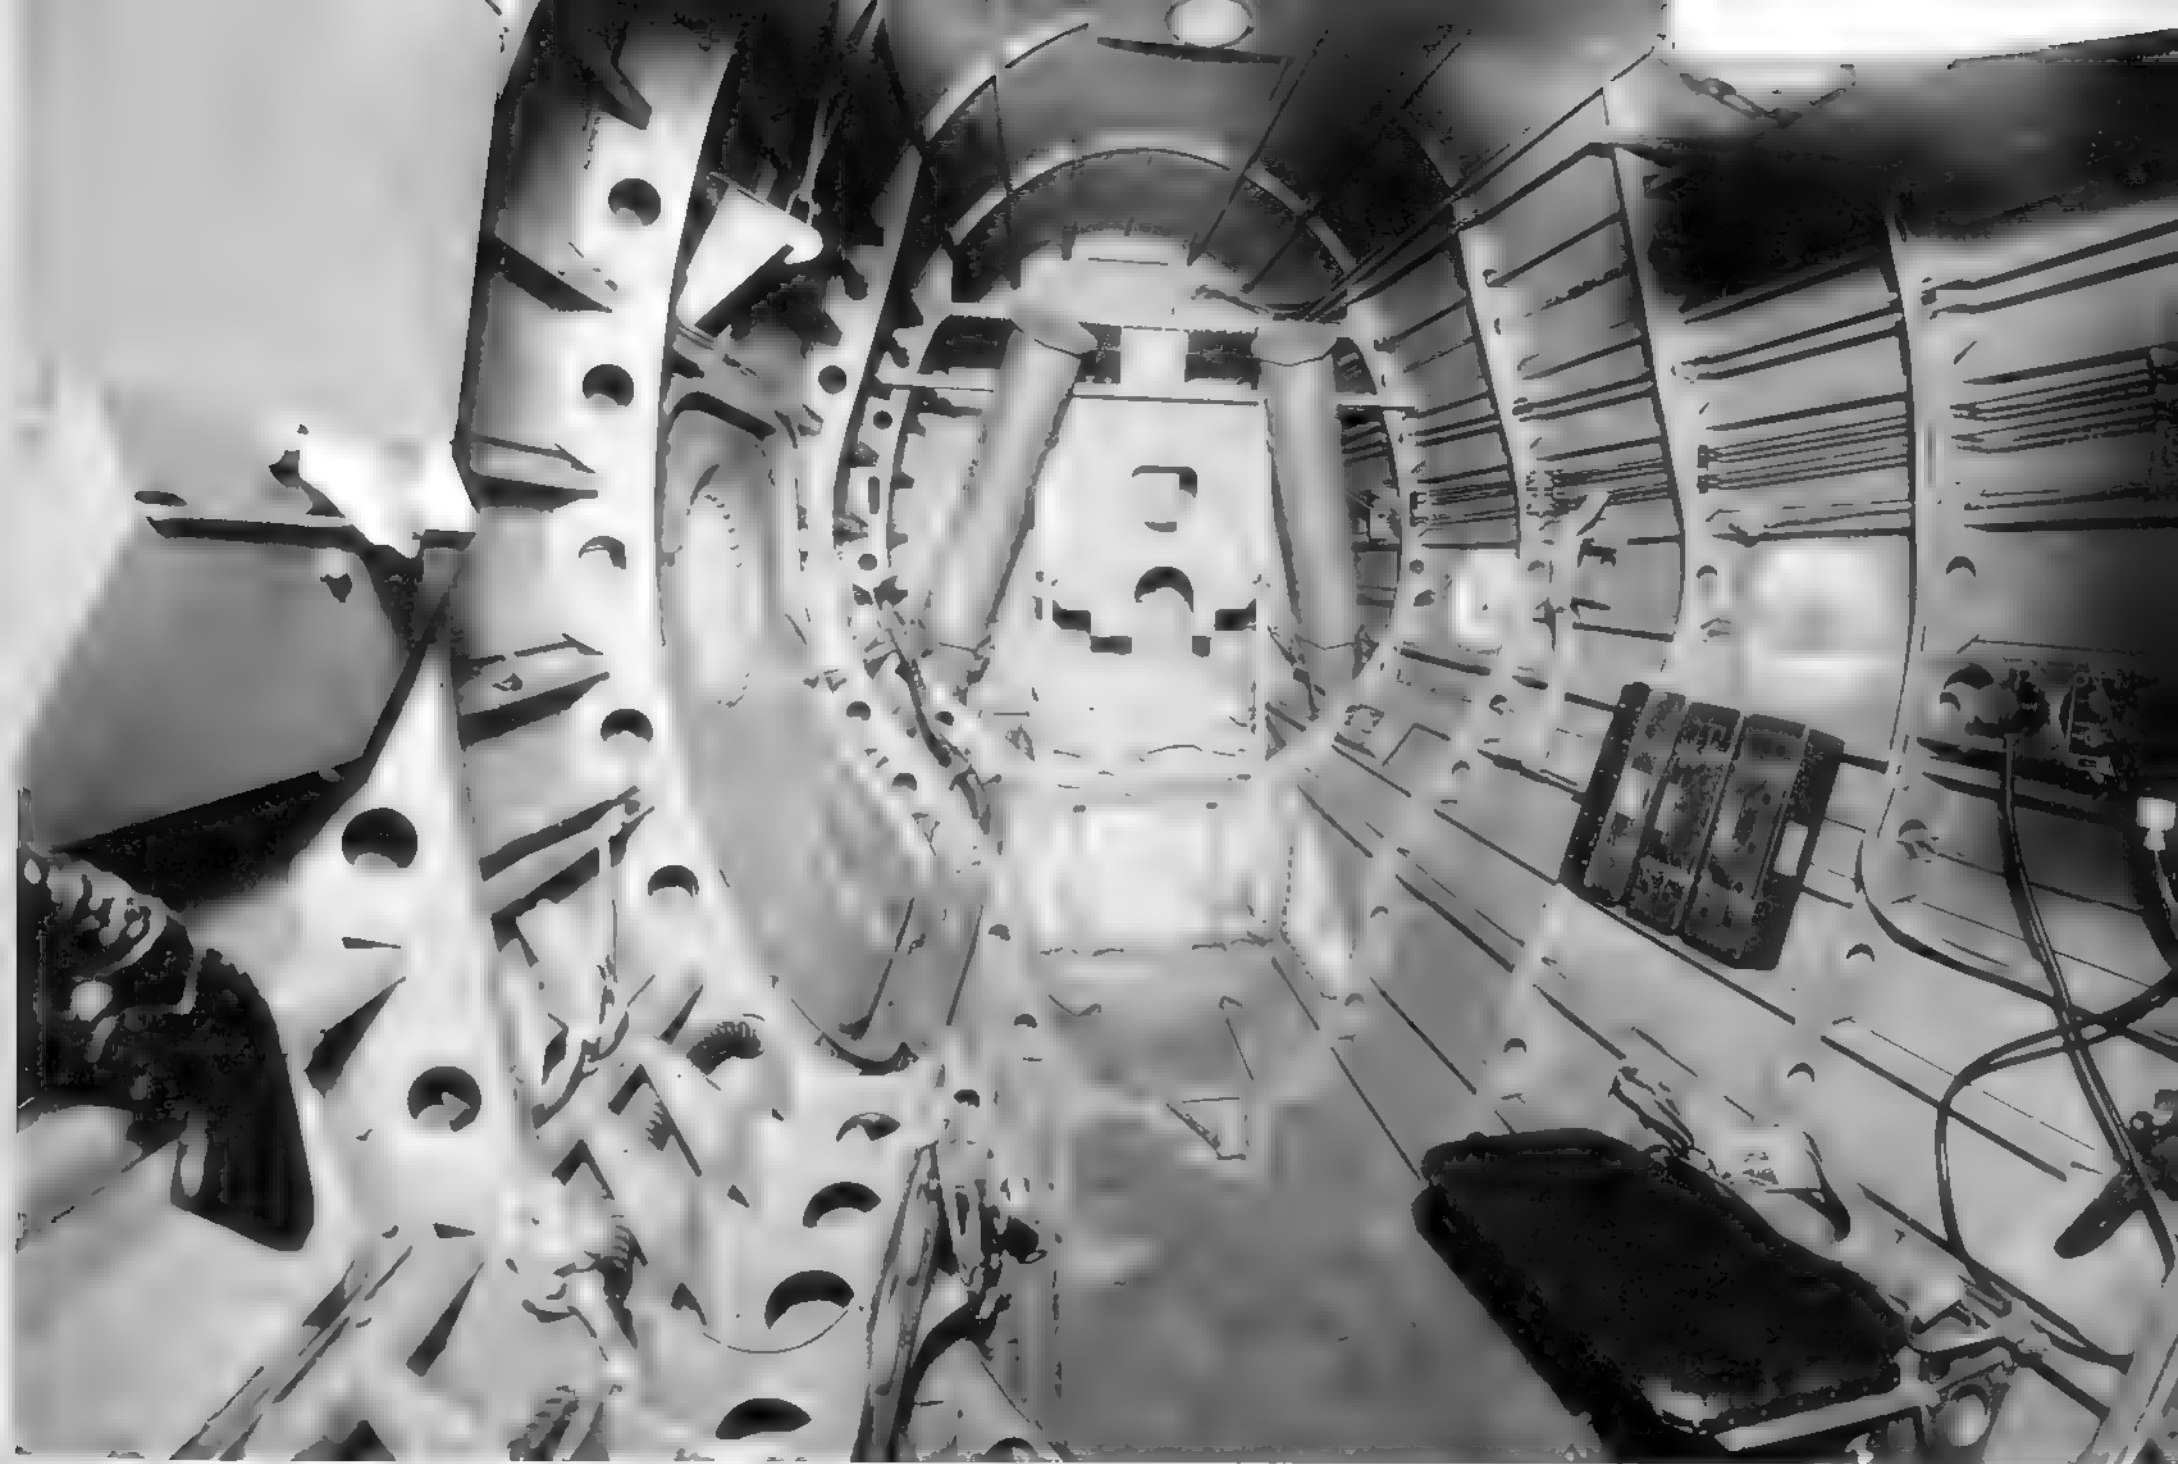
The TBF-1's ventral gun position was placed aft of the bombardier's station; this arrangement was retained in later Avenger models through the TBM-3M. The bombardier's seat was mounted on the port side on early Avengers; this was replaced with the folding seat from the TBF-1C on. The aft fuselage access door was placed on the aircraft's starboard

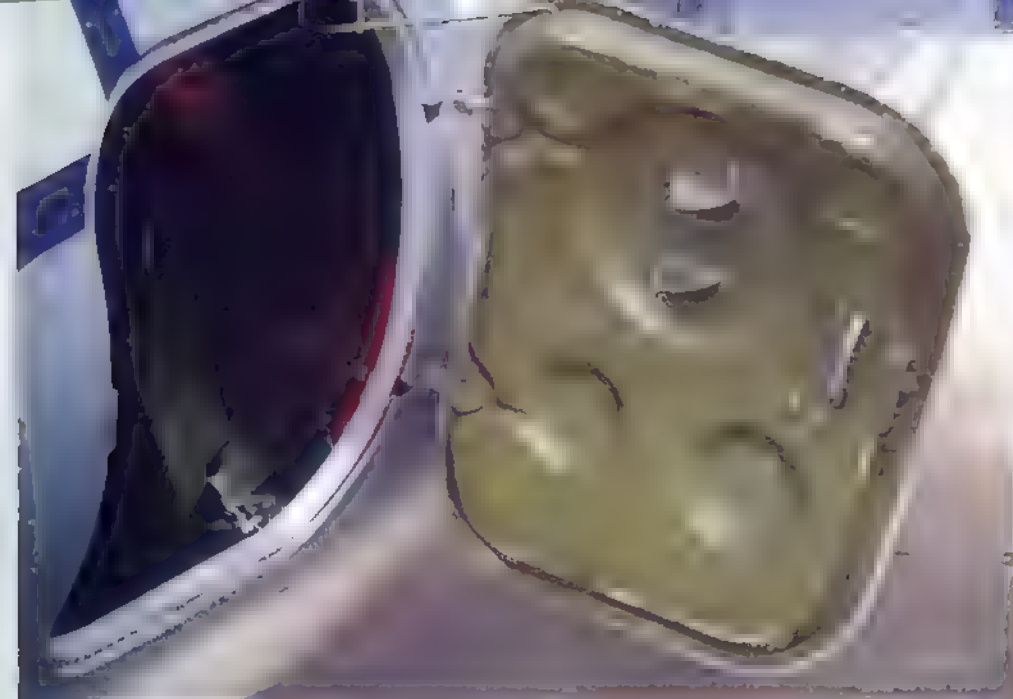
The TBF/TBM bombardier's compartment door opened forward on two flush hinges. A metal door stay was added on this restored Avenger to help the door remain open. This feature was not found on service aircraft. The bombardier radio operator and the turret gunner could jettison the compartment door in an emergency evacuation. An emergency release lever inside the fuselage and forward of the hatch was activated to jettison the compartment door (Glen Phillips)

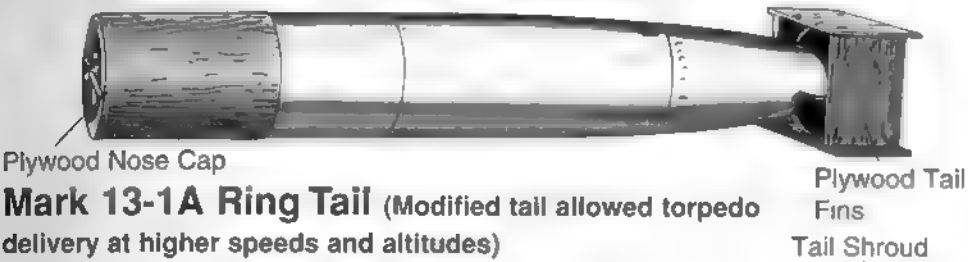
Modified Mark 13 (For additional stability on air delivery; wood nose & tail broke away on impact with water)

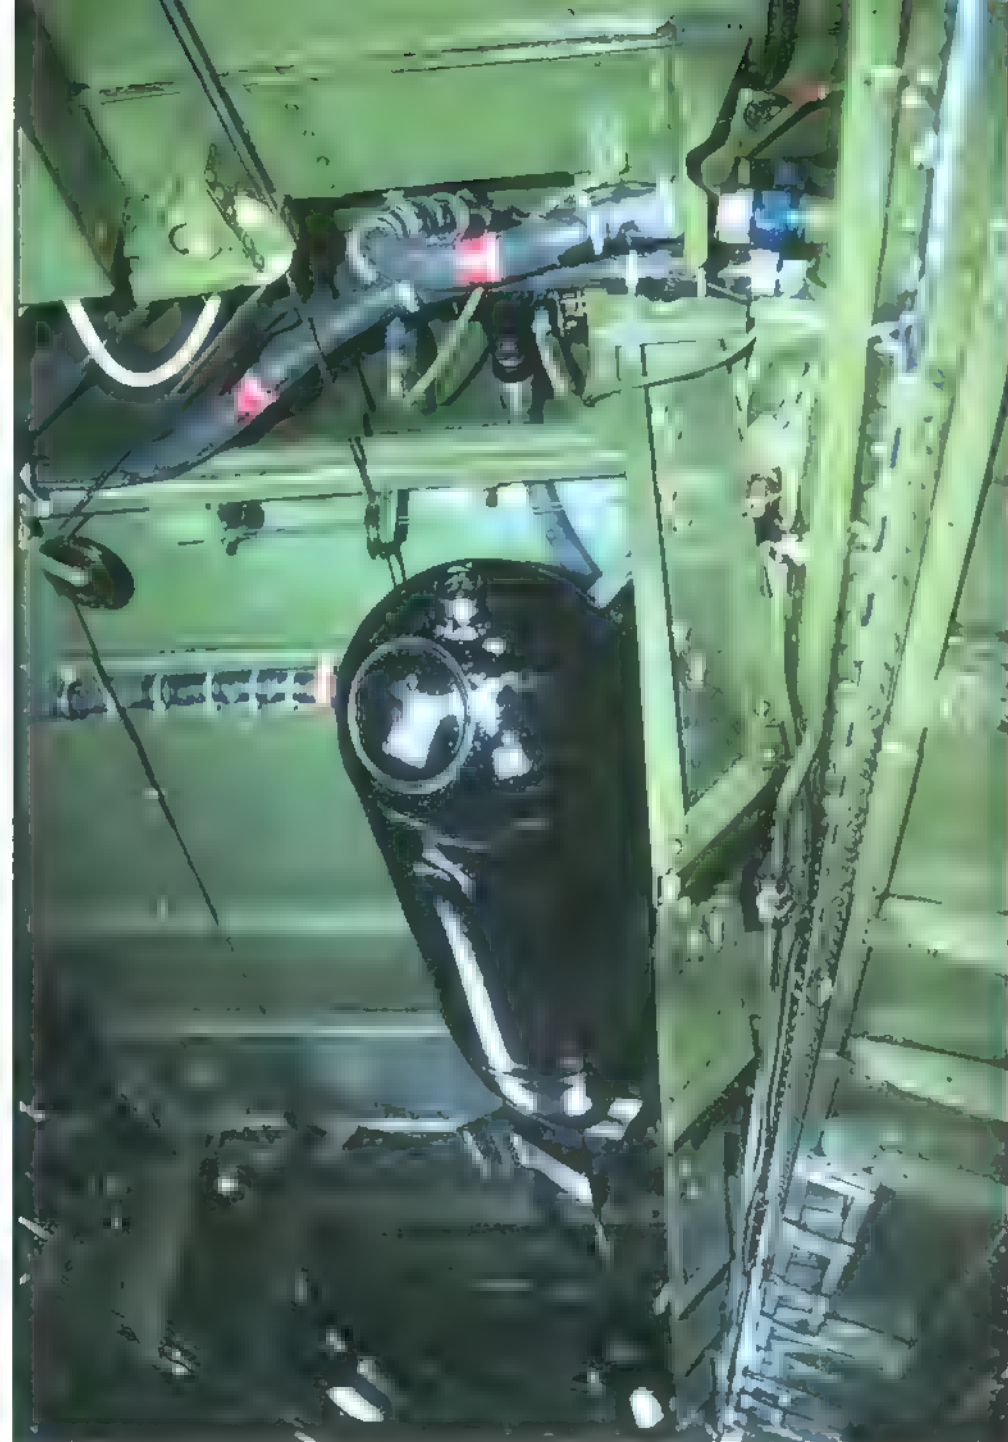
This dummy torpedo was mounted in a decidedly non-standard way! The 'weapon' was secured by three pairs of canvas slings slipped to structural frames inside the bay. This TBM restoration lacked much of the bomb bay plumbing and electrical lines. The interior of this aircraft was painted Zinc Chromate primer (FS34227); however, Avengers bomb bays were usually painted Interior Green (FS34151). (Lou Drendel)

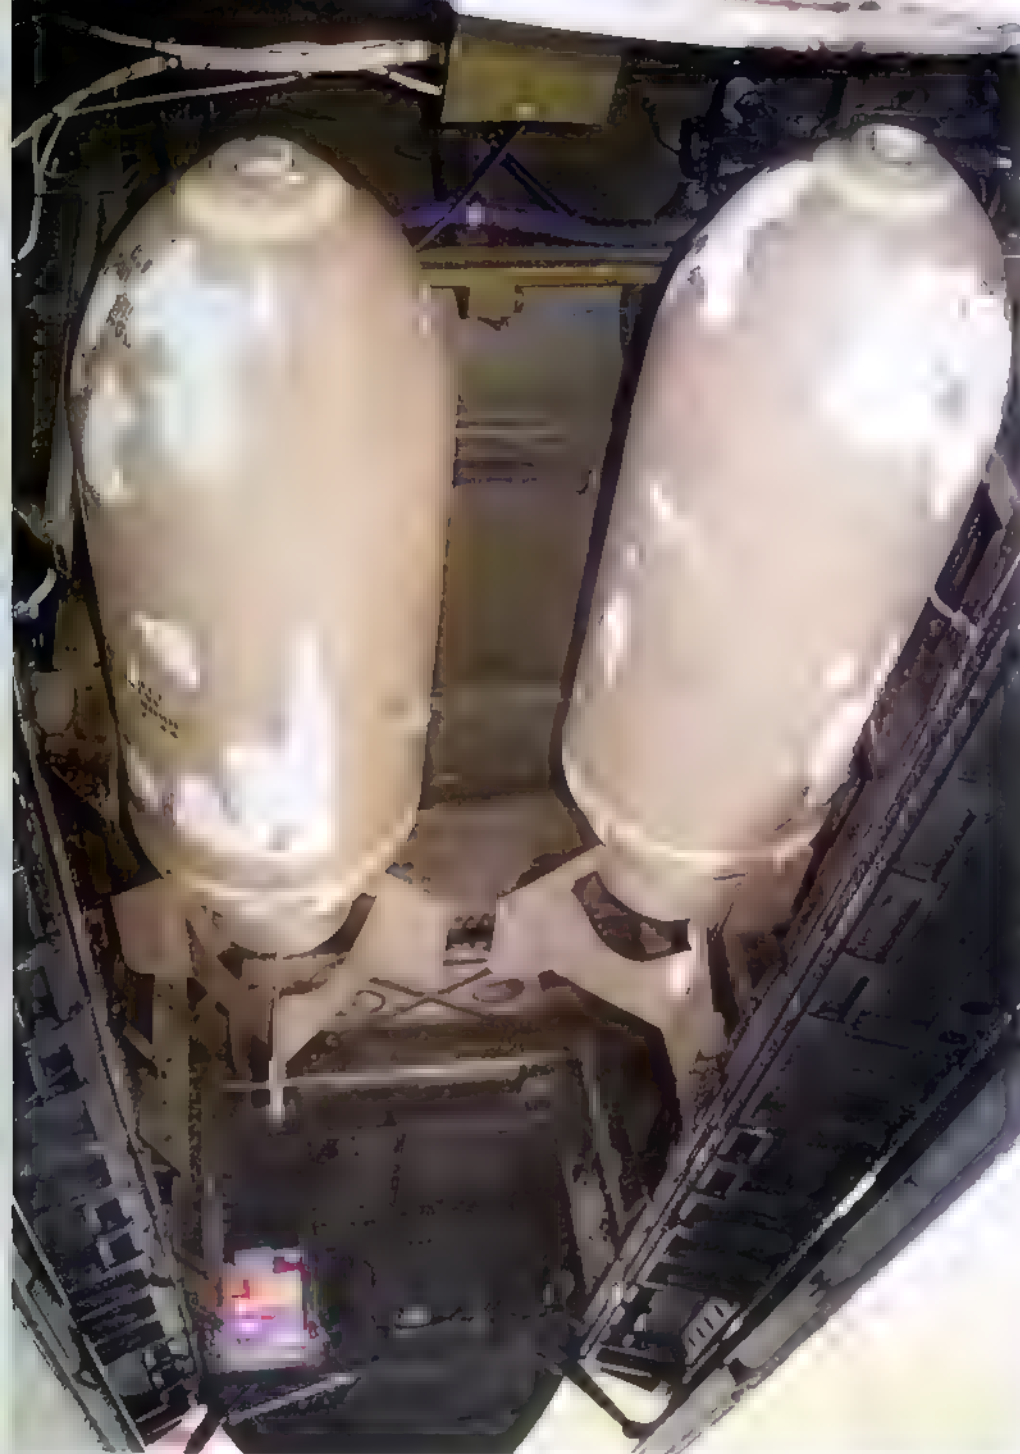
A pair of well-worn inert 500 pound (226.8 kg) bombs were mounted in a restored TBM-3's bomb bay. The bomb bay held either 12 100 pound (45.4 kg) bombs, four 500 pound bombs, one 1000 pound (453.6 kg) General Purpose (GP) bomb, or two 1000 pound Armor Piercing (AP) bombs. The Avenger could also carry either a 1600 (725.8 kg) or a 2000 (907.2 kg) pound bomb, or a 2100 pound (952.6 kg) torpedo. (Lou Drendel)

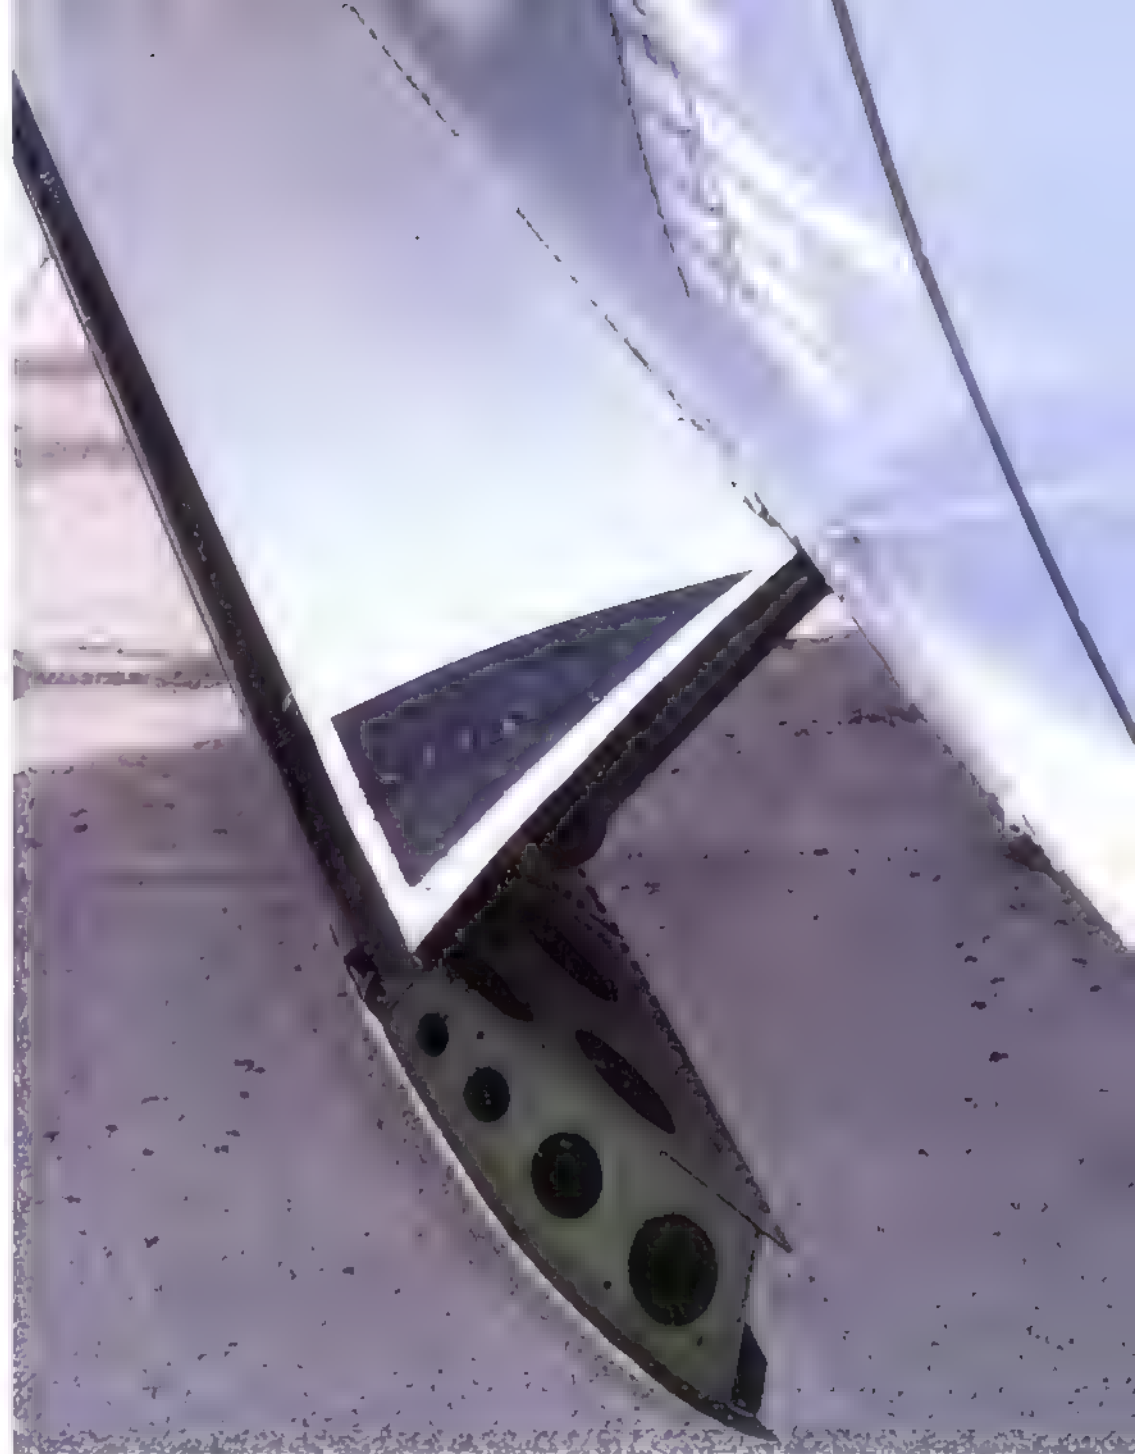
The port upper bomb bay door's aft section included an area marked as a step. This step area assisted personnel in boarding the Avenger over the port wing. All four bomb bay door sections – two each on the port and starboard sides – fit flush with the lower fuselage when the door was closed. The US Navy's 1939 requirement for a new torpedo bomber – met by Grumman's TBF – specified an internal bomb bay. (Lou Drendel)

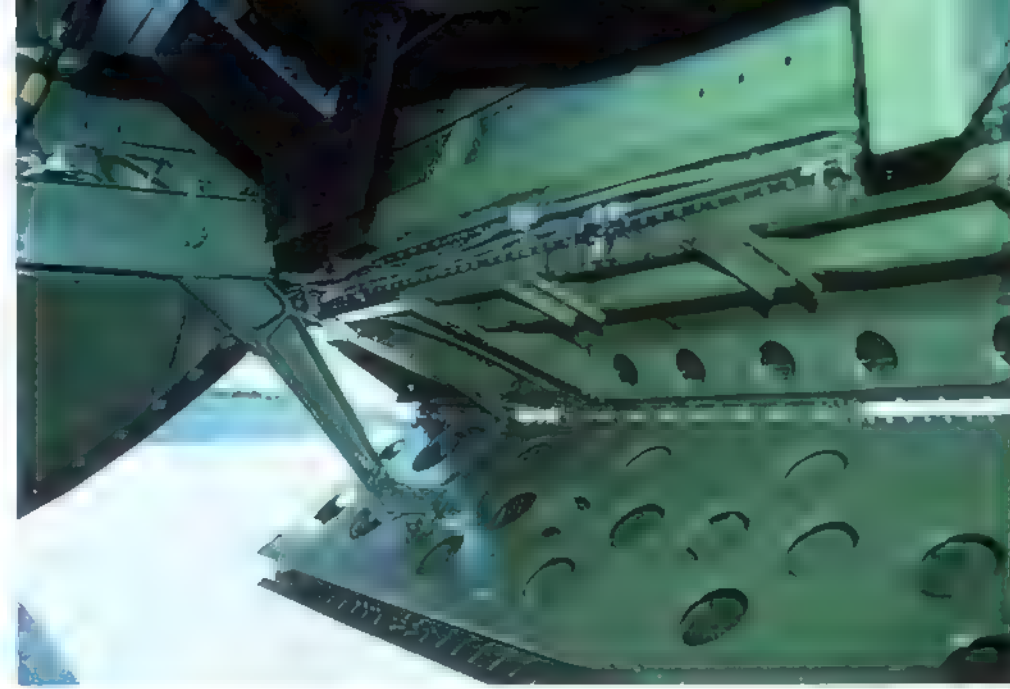
Pulleys mounted above the two bombs in the aft bomb bay area guided the bay door balance cables. These cables ensured proper operation of the bomb bay doors. Additional pulleys were mounted at the front and along the sides of the bay area. Either the bombardier or pilot could release bombs from the Avenger, while only the pilot could release the torpedo. (Lou Drendel)
